RISK AND UNCERTAINTY IN HYDRO-POWER DEVELOPMENT IN UTTARAKHAND POST KEDARNATH AND CHAMOLI FLOOD DISASTERS IN UTTARAKHAND

S.K.Mazumder

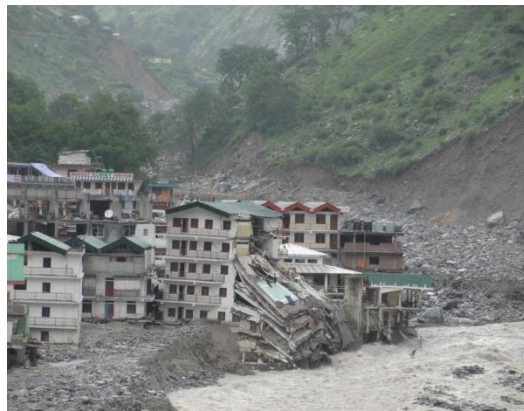
Fig.2 (a): Destruction of Buildings

In June 2013, a mid-day cloudburst centered the North Indian state of Uttarakhand caused devastating floods and landslides, becoming the country's worst natural disaster since the 2004 tsunami. Debris blocked the rivers, causing major overflow. More than 5,700 people were "presumed dead" by 16 July,2013. Destruction of bridges and roads left about 3,00,000 pilgrims and tourists trapped in the valleys leading to three of the four Hindu Chota Char Dham pilgrimage sites. A joint study by the World Bank and the Asian Development Bank estimated that damage (Fig.2a and 2b) to public infrastructure-roads, water transport, buildings- amounted to nearly \$700 million. (Madan, 2013)

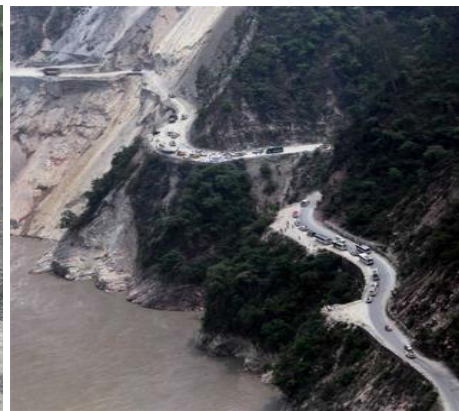
Fig.2(b)Damage of Roads (CBIP,2013)

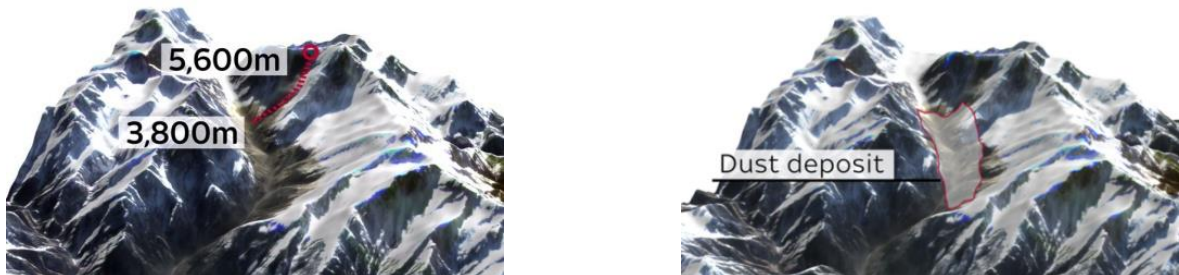
Fig.8 (a) Rock/Ice mass Fall Hilltop to Valley (b) Huge trail of dust (red)in the Valley (Satellite Image: Dr Scott Watson, COMET, University of Leeds)

previous avalanche in 2016 triggering landslide with a huge trail of dust as it travelled down the valley generating immense heat and melting of ice illustrated in Fig.8 (a) and 8(b)
