Discusser would like to convey his deep appreciation for the paper. In fact Mr. Chitale in an earlier paper (chitale, 1999) wrote on Kosi river predicting possible change in its course. Discusser also had written papers on Kosi (1985) regarding effectiveness of long groynes. Fig. 1 & 2 shows the devastation brought about by river Kosi due to change of its course on August 18 th,2008 due to breach in its left embankment about 12 km upstream of Kosi Barrage.

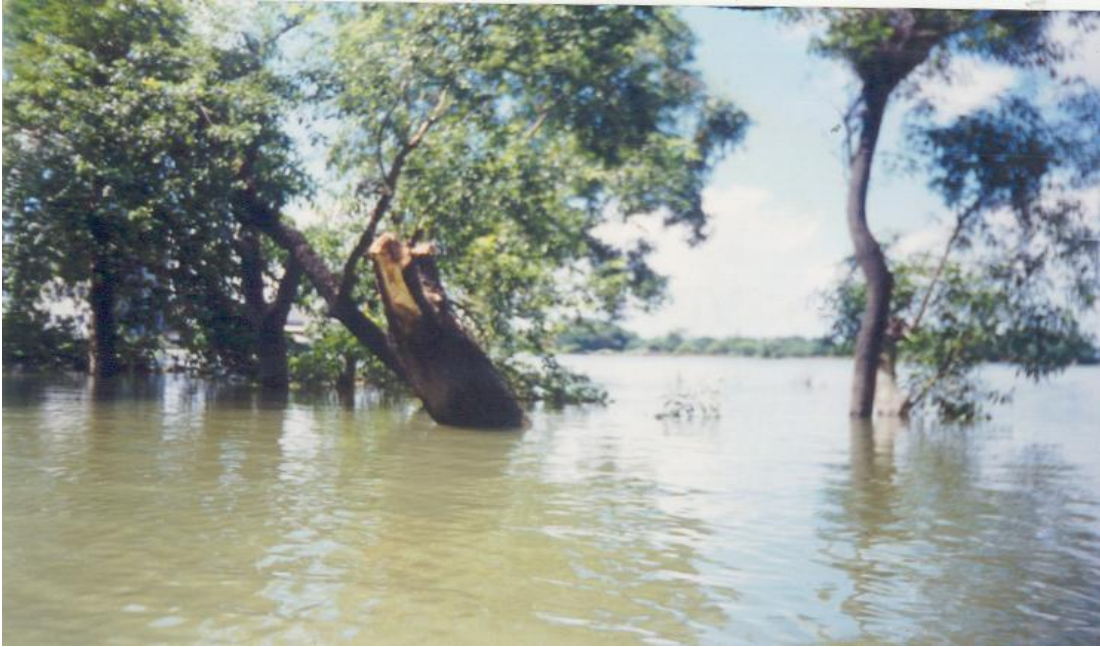
Fig. 3 Innundation of Agricultural and Mango Trees in in Malda District in West Bengal i

What was apprehended exactly happened. The mattresses about 60 long and 1m thick laid normal to river bank along with crated stone bed bars (60mx3mx3m thick) got washed out and the breach occurred at Panchanandpur where the river Ganga has eroded left bank and moved 7km inside Malda district in West Bengal causing unimaginable loss of properties, agricultural lands and sufferings of the people. Project authorities constructed nine numbers of retired embankments, one after another, but all of them got washed out. Damages that occurred in.1998 flood alone (similar damages had occurred several times after barrage construction) can be assed from the two photographs given below (Figs.3&4)

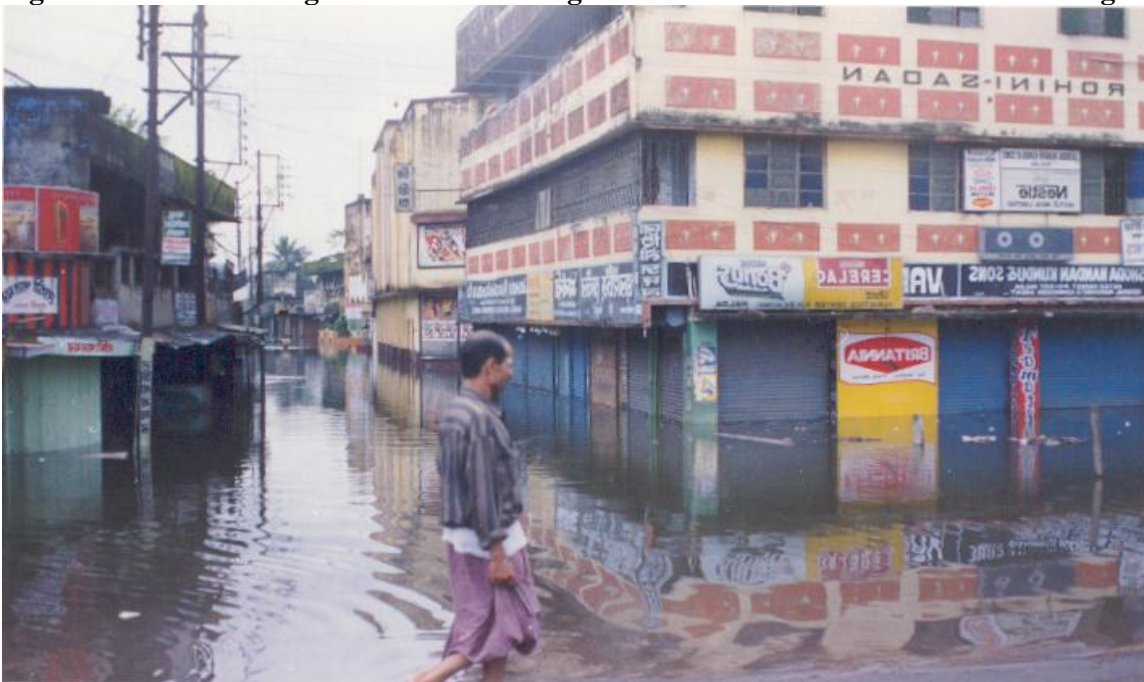
Fig.4 1998 Flood water destroying Properties in Malda Town under 4m depth of water

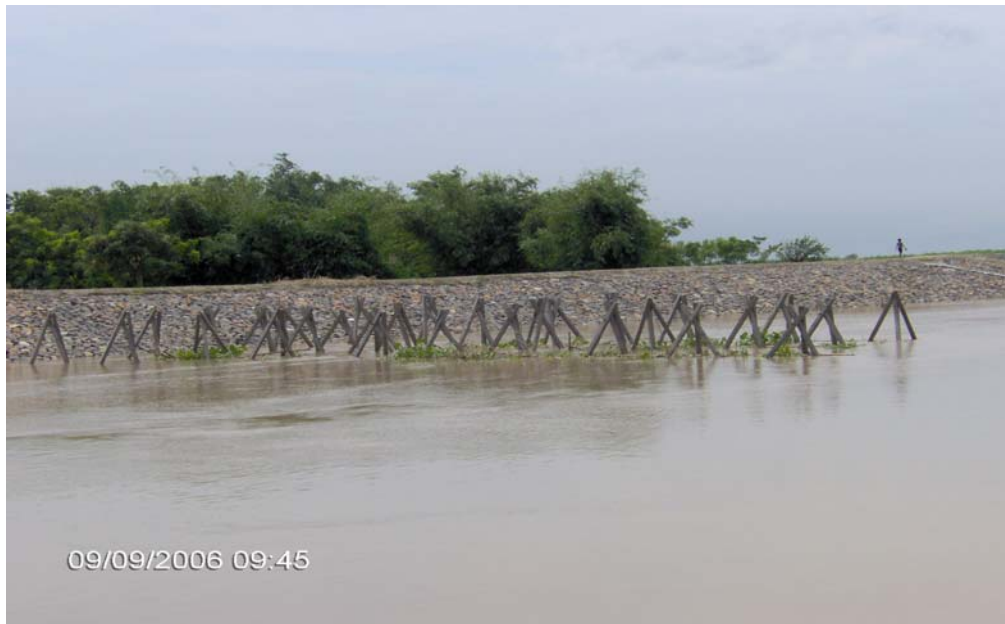
Fig. 5 showing one row of Porcupines used for bank protection upstream of Farraka barrage.

Permeable spurs made of piles or porcupine etc with permeability not less than 30% and not more than 50%, properly designed and constructed (Lagasse, 1995), have been found to be highly effective in controlling bank erosion due to dissipation of energy in the micro turbulence, As the flow passes through the body of the spurs, there is hardly any flow curvature and concentration of flow near their heads.(Mazumder,2008). After making several correspondences, CWC authorities finally switched on to porcupine type permeable spurs ,as shown in Fig.5 .Results obtained are very encouraging.
