Chamoli Valley Flood and its Impact on Hydro-Power Projects in The Uttrakhand

Shivdayal Sharma¹ and S.K. Mazumder²

ABSTRACT

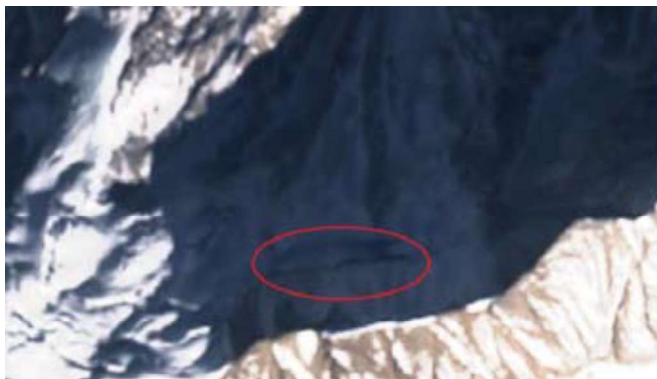
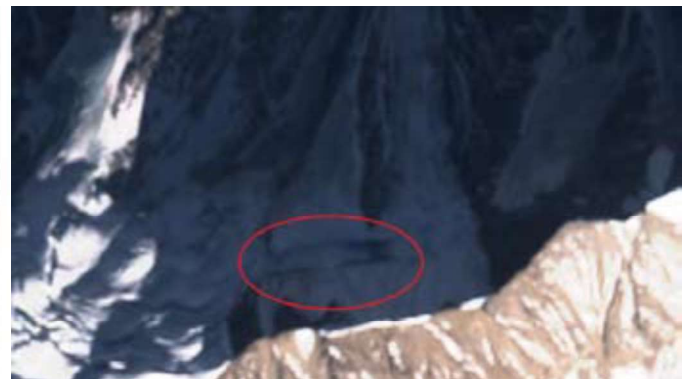
Fig. 5 : Close-up View of the Crack Propagating in The Mountain (Pic: SentinelHub)

At roughly 5,600 masl, a crack had formed on the side of the mountain. Researchers monitored satellite images to investigate the cause of landslide; but it is difficult to conclude. Crack can be seen in Fig. 5(a) in a satellite image of the peak, which was captured on 2 February - five days before the disaster. The horizontal line of the crack is much more visible when the satellite is zoomed in, as shown in Fig.5 (b). Using satellite imageries, it was possible to see that the crack had been developing for

some time - with evidence of the first crack visible in the satellite image from 1 January 2020. Scientists believe it was this crack that further increased causing an enormous block of rock and ice to fall into the valley on 7 February. It is estimated that the block was over 2 million cubic metres in size and fell nearly 2 kilometers, almost vertically, before impinging on the valley floor. The graphic shown in Fig.6(a) shows the path the rock fall and the distance it travelled (in red line). As it rolled down the valley, the mass of fragmented rock ploughed through an ice deposit leftover from a previous (2016) avalanche in the area, leaving a trail of dust in its path shown in Fig.6(b).

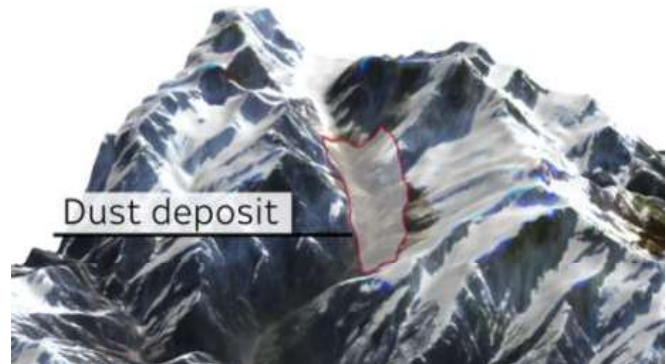
Fig. 6(b) : Huge trail of dust (red)in the Valley (Satellite Image: Dr Scott Watson, COMET, University of Leeds)

As mentioned, the block fell 1800 metres (from 5600 to 3800 masl) into the valley below. Dr Scott Watson, (Anon n.d., 2021), COMET, University of Leeds, believes that the mass of rock and ice ploughed through a deposit of rock and ice from a previous avalanche in 2016 triggering landslide with a huge trail of dust as it travelled down the valley generating immense heat and melting of ice illustrated in Fig.6 (a) and 6(b)

10:30 IST, on Feb. 7th just before it reached the Tapovan Hydropower Project site. Ash color area in Fig. 6 (a) shows the sediment deposited in the valley and adjacent slopes of the river valley. The released zone of the rockslide is marked in red. Fig. 6(b) indicates damaged Tapovan barrage in the valley overtopped by water and incoming sediments.

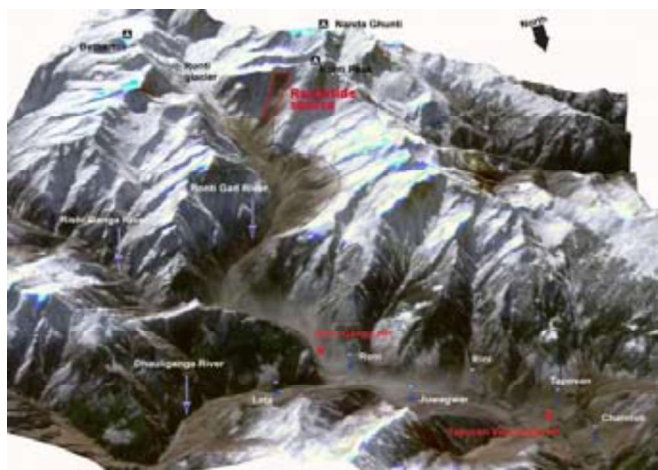
Fig. 7(a) : Three Dimensional View of (a) Rock Slide Near Tapovan H.E. Project

Figure 7 gives a 3D view of the origin of the rockslide and the debris flow captured on a satellite image at

As some of this ice body was still present just after the event below Ronti peak in 2021, it may be concluded that a fraction of this previous deposit ($< 7.2 \times 10^6$ m³), was fluidized by the available energy. There are also reports from observers of the event of a pungent smell, suggesting water-saturated sediments were mobilised and added to the fluid content of the debris flow. Locations of 2016 and 2021 events are shown in Fig.7.

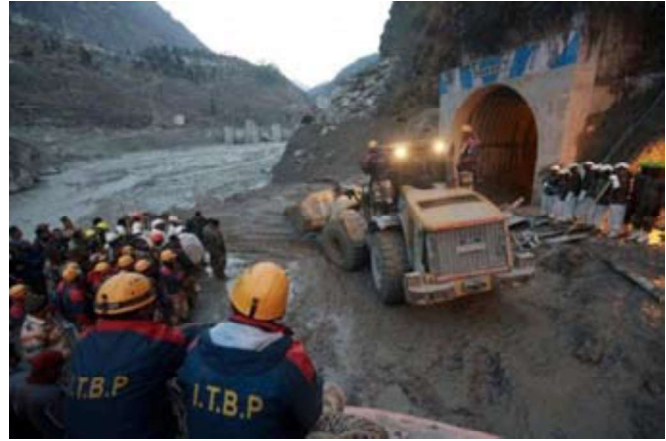
Fig.10 : National Disaster Response Force (NDRF) and Indo Tibetan Border Police (ITBP) search for workers trapped in a tunnel in Tapovan area on February7- 8, 2021.

impact site, was the first to be hit by the debris after the rockslide. The unfinished Tapovan Vishnugad Hydropower Project (520 MW) , 8 km downstream from Rishi Ganga Hydropower Project, was the second hydropower plant hit by the flood. The diversion dam of this run-of-the river type project faced massive damage from sedimentation and the dam was filled with debris, which can be seen in the remote sensing images taken before and after the event. Two power projects — NTPC’s Tapovan-Vishnugad hydel project and the Rishi Ganga Hydel Project — were extensively damaged with scores of laborers trapped in tunnels as the waters came rushing in. At least 32 people were dead and over 190 missing. And the trail of destruction can be seen in Figs. 8, 9 and 10.

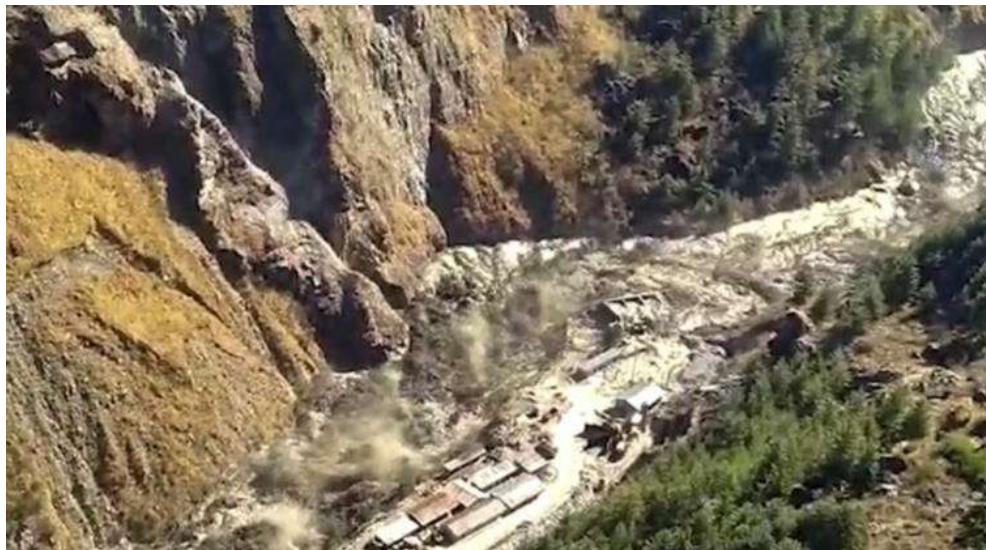
Fig. 9 : Land Slides with Flood Water, Muds and Debris Flowing at Chamoli District in Uttarakhand, India on 7-8 Feb. 2021 (Pic: AP)
